FLORIDA DEPARTMENT OF EDUCATION

SUBJECT: Release of Advisory on Carpenter Bus Defects

National Highway Traffic Safety Administration
Carpenter School Bus Advisory
June 2003

South Carolina Department of Education, Transportation
Repair of Carpenter Body Structure
7-10-2003

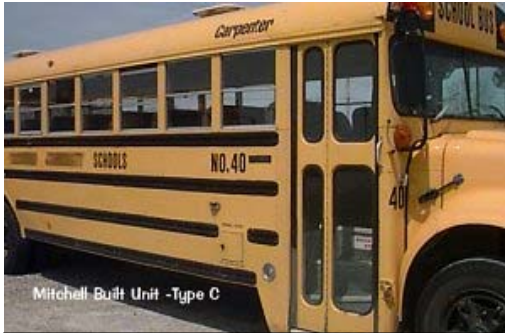
Figure 1: Mitchell built type "C"

2. There are noticeable differences between the rub rail locations for the two Carpenter plants. The rub rail at the floor line in all buses made at the Mitchell plant is interrupted at the wheel openings. The rub rail at the floor line in all buses made at the Richmond plant is continuous and is located just above the wheel opening. If the 6 digit body number starts with the number 4, then the bus was built in the Richmond, Indiana plant and utilized full length body bows.

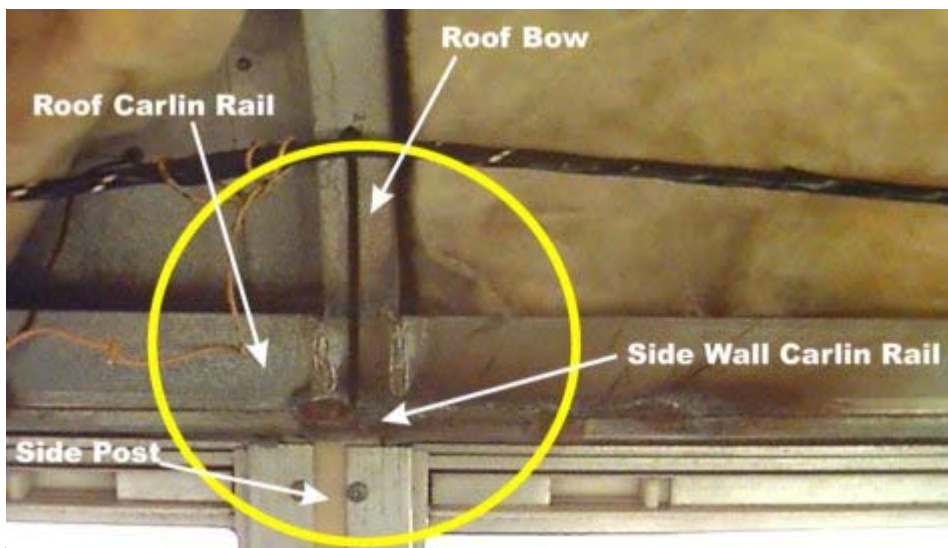
Figure 5: Photo depicting weld locations

At this time, we strongly encourage owners and operators of the Carpenter school buses described below to inspect them to determine if there are structural weld failures in the roof structure. The welds in question are located at the junction of the vertical side posts (between the windows) and the horizontal structural member (the "Carlin" rail) above the windows. The inspection will require the removal of interior panels as well as the removal of some of the windows. The following information is provided for your consideration and use:

3. All Carpenter school buses built in Mitchell, Indiana, no matter what the body number, should be inspected for cracked or broken welds in the roof structure. The photograph below shows the locations of the components that are welded together.

NHTSA recommends that the following actions be taken with respect to any Carpenter school bus built in the Mitchell plant that has been found to have cracked or broken welds in the roof structure:

The bus should be taken out of service and replaced as soon as practicable.

If the bus must continue in use, the cracked or broken welds should be repaired as soon as possible by qualified service personnel.

In order to minimize the risk of a rollover, the bus should be used on routes that operate in low speed environments.
